# FALCON SERVICE ADVISORY

FSA2000-80-00-07-R1

## New Engine Air Starter P/N 3505656-7

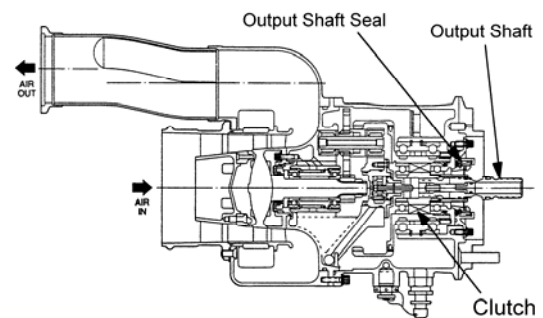
Evaluation of the returned units revealed that the oil leakage originated from the output shaft carbon seal damaged by heat. This heat was generated from high speed contacting surfaces.

Normally, the output shaft decouples when the designed decoupling drag torque is exceeded. This occurs during normal overrunning with the main engine and when the starter clutch drive shaft bearings or clutch components are worn to the point of creating this drag.

A new air starter P/N **3505656-7** has been developed to improve the output shaft seal and the decoupler design.

The output shaft seal becomes a non-contacting seal eliminating heat generation that the carbon and rotor contacting surfaces produced.

The decoupler has been redesigned to eliminate nuisance decouplings.
