# DUNCAN INTELLIGENCE

## ProLine 21 Display Blanking/Failing

## F2000 Hydraulic Pipe Interference

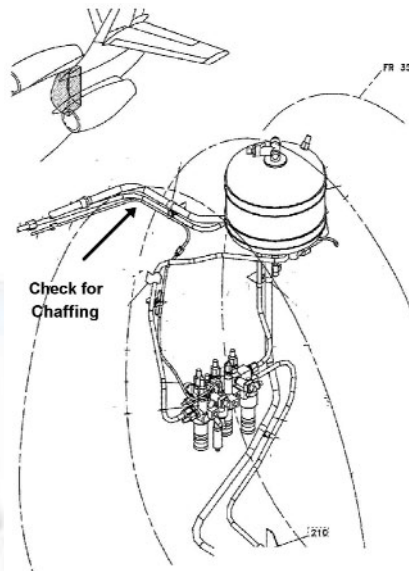
During your next detailed inspection of the nacelles and pylons, pay particular attention to engine #2, pump #1 out, hydraulic pipe, p/n F2MA751505329A1.

After removal of door 444CB, which is the aft-most lower pylon

panel, look for broken support clamps holding the pipes as they pass through the pylon and into the rear service bay. If any of these nylon clamps are broken (p/n 78654-04)

perform a detailed

inspection of all of the hard lines for chaffing, especially as they pass through into the rear bay.
