# Advisory Wire

REFERENCE NO:	AW700-32-0804, Rev 1	INFORMATION TYPE:	Maintenance
ATA:	32-43	EFFECTIVITY:	Global Express / XRS Global 5000 Global 5000 feat. Vision Flight Deck Global 6000 Global 5500 Global 6500
SUBJECT:	<b>Restoration (Replating) of the Brake Assembly – Torque Tube</b>

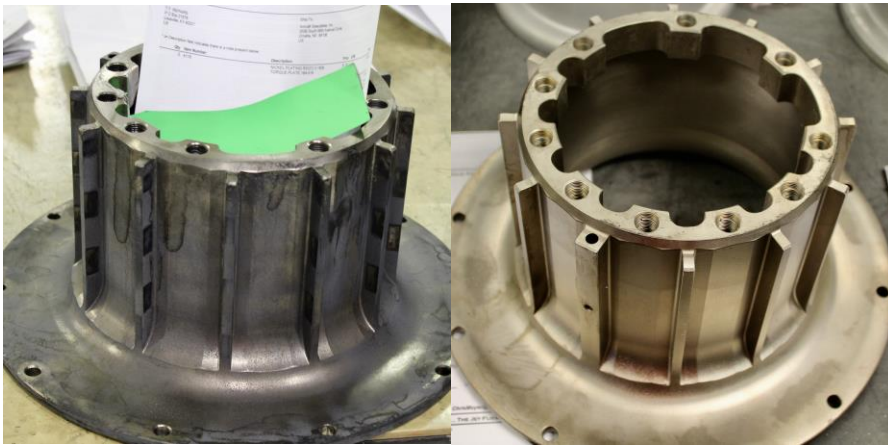
surface which will, with time, remove material at the carbon stator slots resulting in enlargement beyond limits and rejection of the heat sink.

Before and after the Nickel plating restoration

The new restoration procedure of the brake assembly is introduced in the MPD (ref. 1.1) as an optional 60-month task and will make sure the torque plate remains in good condition throughout the life of the aircraft. Taking care and maintaining your torque plate will help prevent stator slot enlargement in your heat sink. The restoration will also include new seals for the adjusters which will help prevent leakage.
