SENSORS AND INTEGRATED SYSTEMS - OHIO  
**SERVICE NEWSLETTER**

**Pneumatic De-icer Warranty Claims  
ATA Chapter 30**

**SNL 05-064**

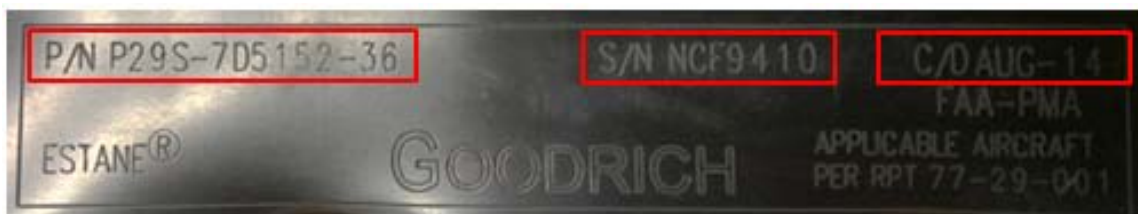
**Figure 1 – Laser Brand Example**

If photographs are not possible or do not provide sufficient information, the laser brand (see Figure 1) and a small section of the pneumatic de-icer that shows the alleged warrantable defect should be cut from the de-icer and returned. The laser brand is generally located on the lower wing surface on the inboard end of the de-icer.

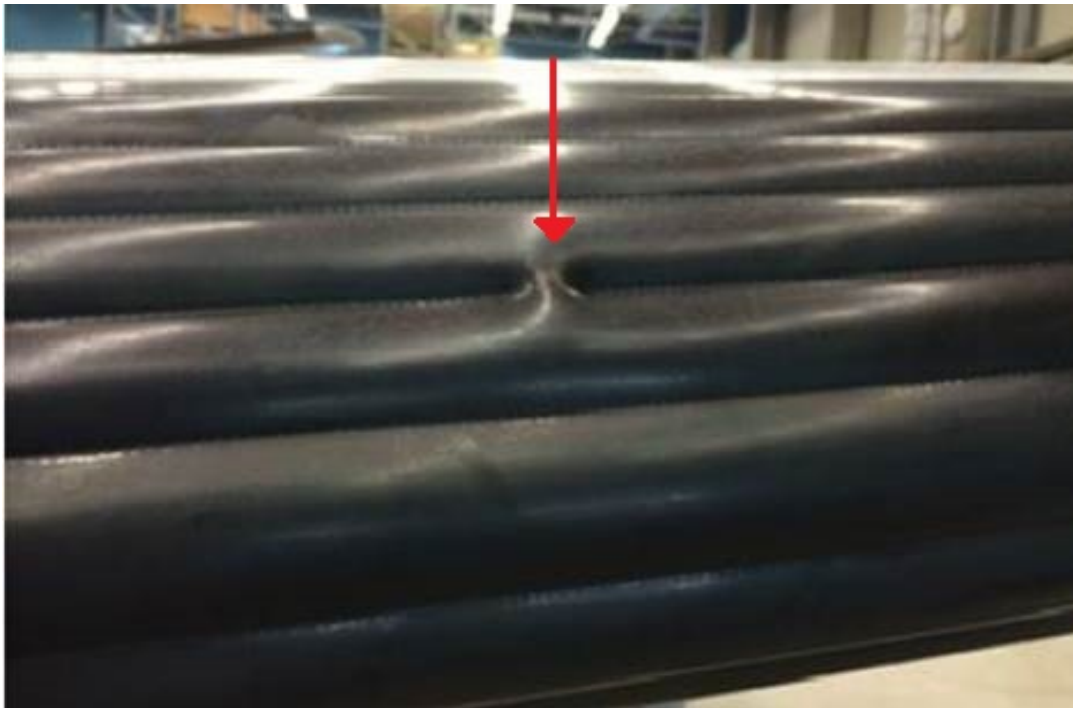
**Figure 4 - Broken Stitch**

- (2) Broken stitch - stitching that separates the air tubes in the de-icer has broken, making two separate tubes appear as one in the area of the broken stitch. A broken stitch cannot be repaired. A broken stitch may indicate a warrantable defect or a non-warrantable environmental failure such as foreign object damage (FOD), static burn or lightning strike, or a wear-out failure, depending on time and flight hours since installation.

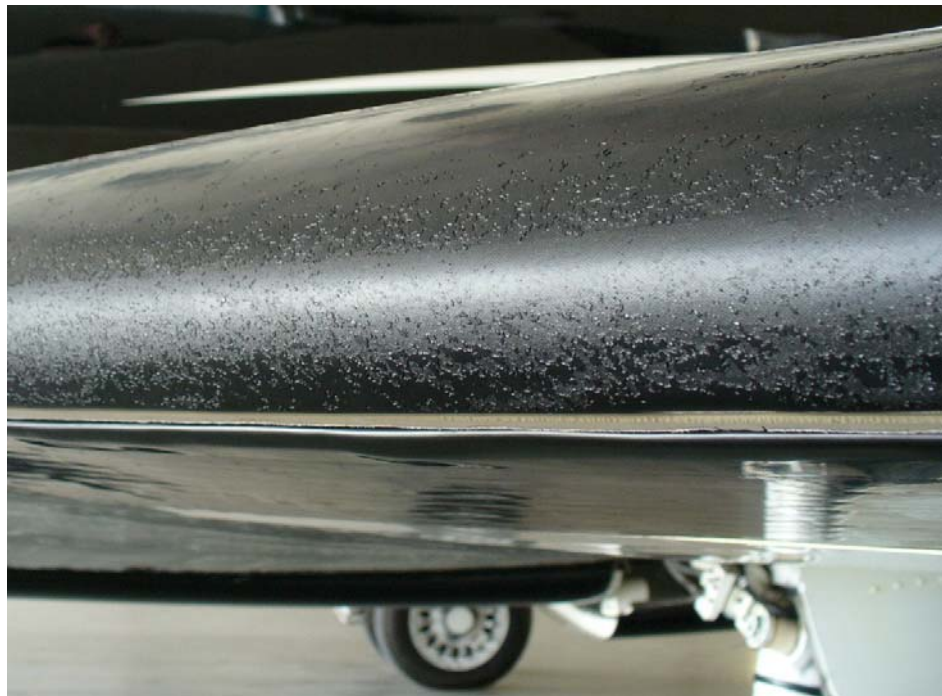
**Figure 6 - Erosion Example**

- (4) Erosion - wear and tear on the de-icer surface ply due to environmental conditions experienced in flight. Erosion is not a warrantable defect.

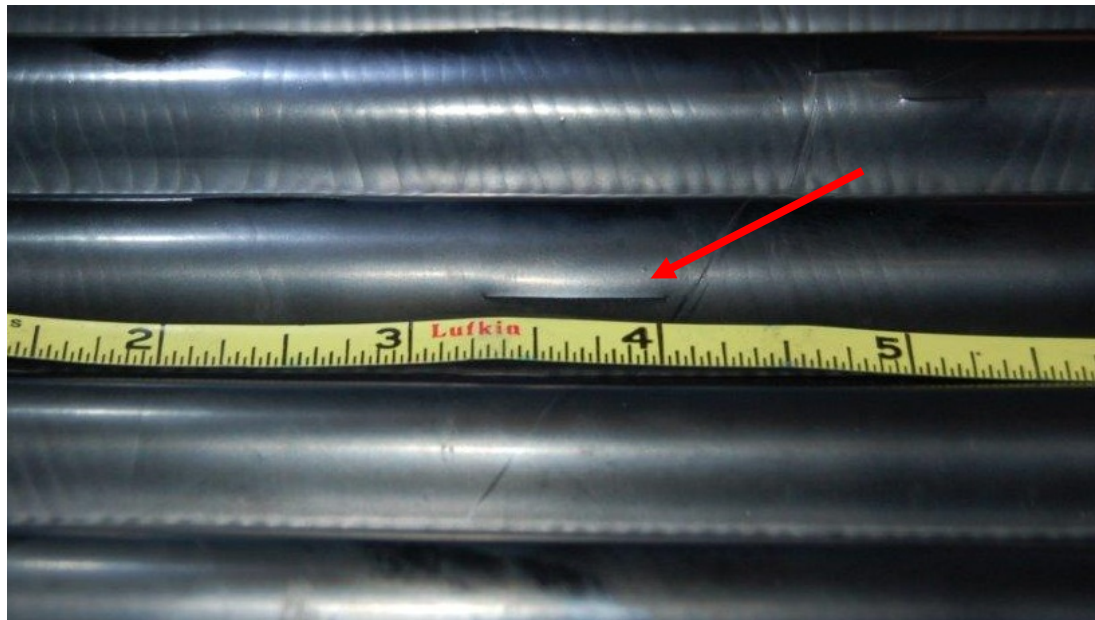
**Figure 7 - Split Example**

- (5) Tear, rip, split - air leaking break in the de-icer surface that can be of varying depths. Generally speaking these are not warrantable defects; rather are due to FOD, cold-cracking, cold impact damage, excess waxes or coatings. Depending on size and depth, these can usually be patched.

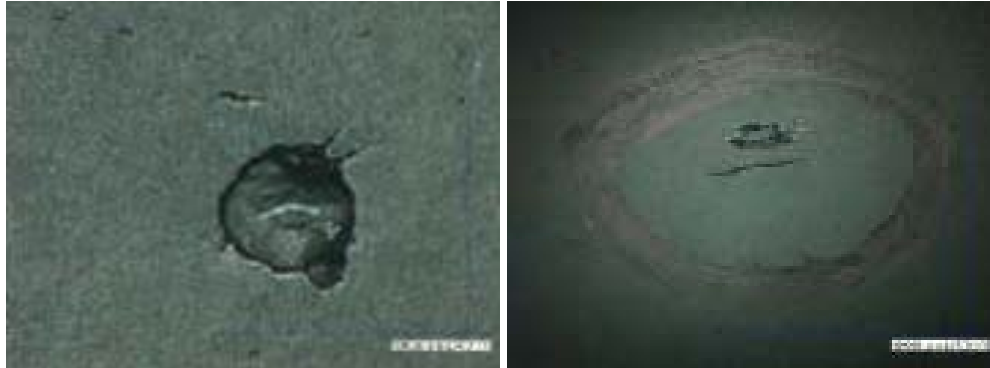
- (6) Pinholes - means any air leaking hole 1/16 inch (0.0625 in./1.6 mm) or smaller, often caused by static burns on the de-icer. Generally speaking, pinholes are not a warrantable defect; rather are due to improper or worn conductive edge sealer, electrical storms or by erosion through the de-icer surface ply. Pinholes can usually be repaired depending on number.

**Figure 8 – Pinhole caused by static (left) or FOD (right)**

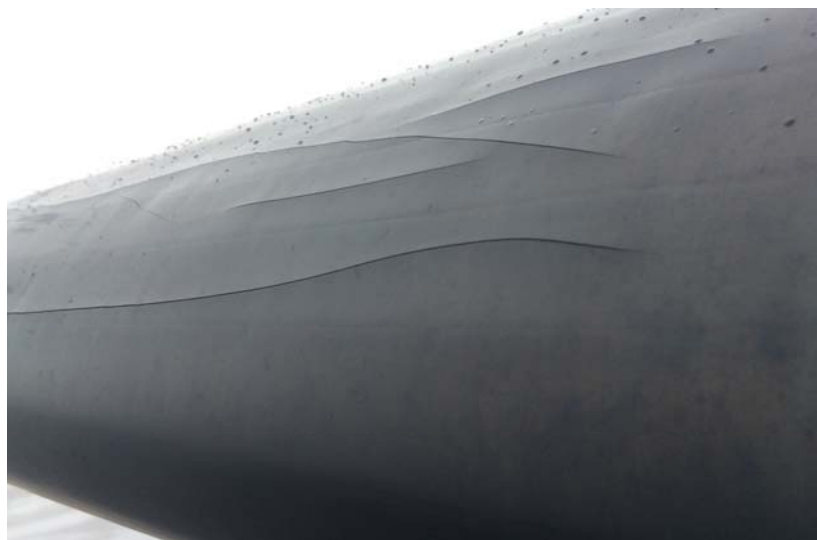
**Figure 9 – Cold-cracking Example**

- (7) Lightning strike - may cause a significant hole burned through the de-icer. Damage to the de-icer from lightning strike is not a warrantable defect.
- (8) Cold-cracking - long slits or cracks in the de-icer that appear relatively straight and usually in the middle of the air tubes. Cold-cracking occasionally occurs when de-icers are cold-soaked below their designed operating parameters (-40 °F/-40 °C) and inflated while brittle. Cold-cracking is not a warrantable defect. Cold-cracking may be repaired depending on the extent of the damage.

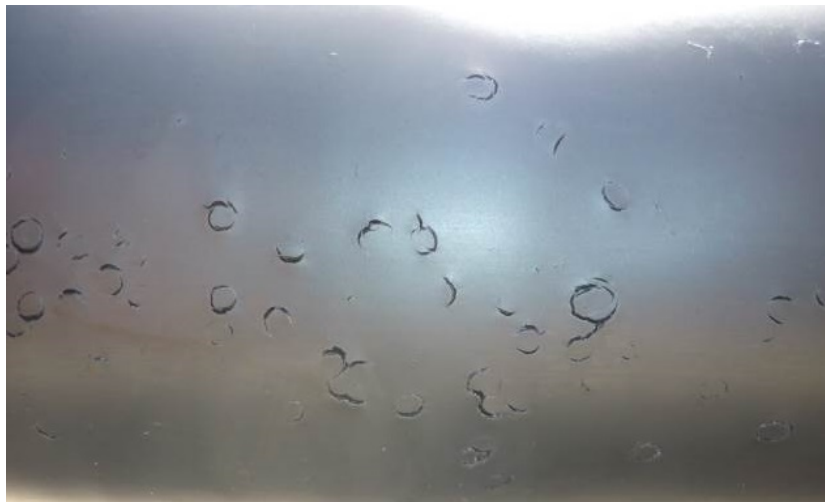
**Figure 10 – Cold Impact Damage Example**

- (9) Cold impact damage - small dents or cracks, often in a curved or half-moon shape. Cold impact damage occasionally occurs when de-icers are cold-soaked below their designed operating parameter (-40 °F/-40 °C) and encounter environmental foreign objects such as ice crystals or hail in flight. Cold impact damage is not a warrantable defect. Cold impact damage may be repaired depending on the extent of the damage.

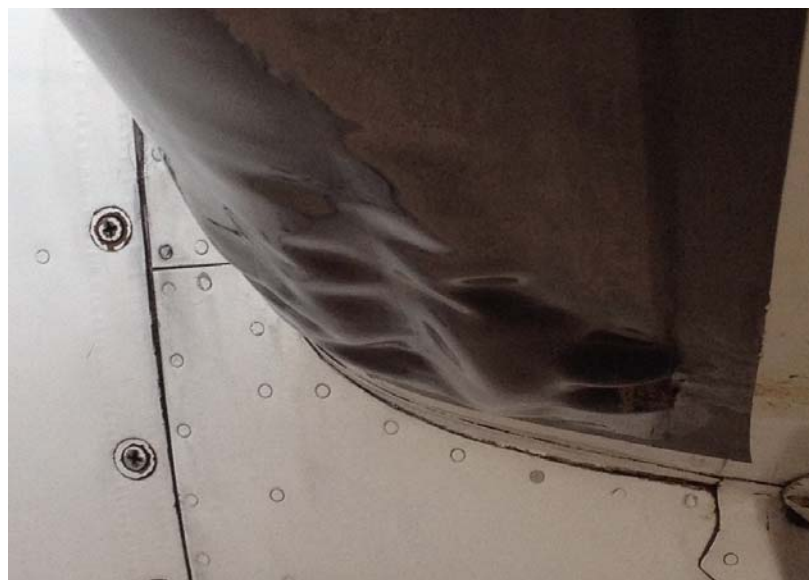
**Figure 11 – Fuel Contamination Example**

- (10) Contamination - a foreign substance such as oil, fuel, grease, unauthorized coatings or repair materials, or improper application of authorized coatings or repair materials. Damage due to contamination is not a warrantable defect.
